**Assessment of durability  
of Deckmaster  
waterproof system**

Prepared for:  
Mr David Tomlinson  
Resdev Ltd

13 May 2013

Client report number 287055

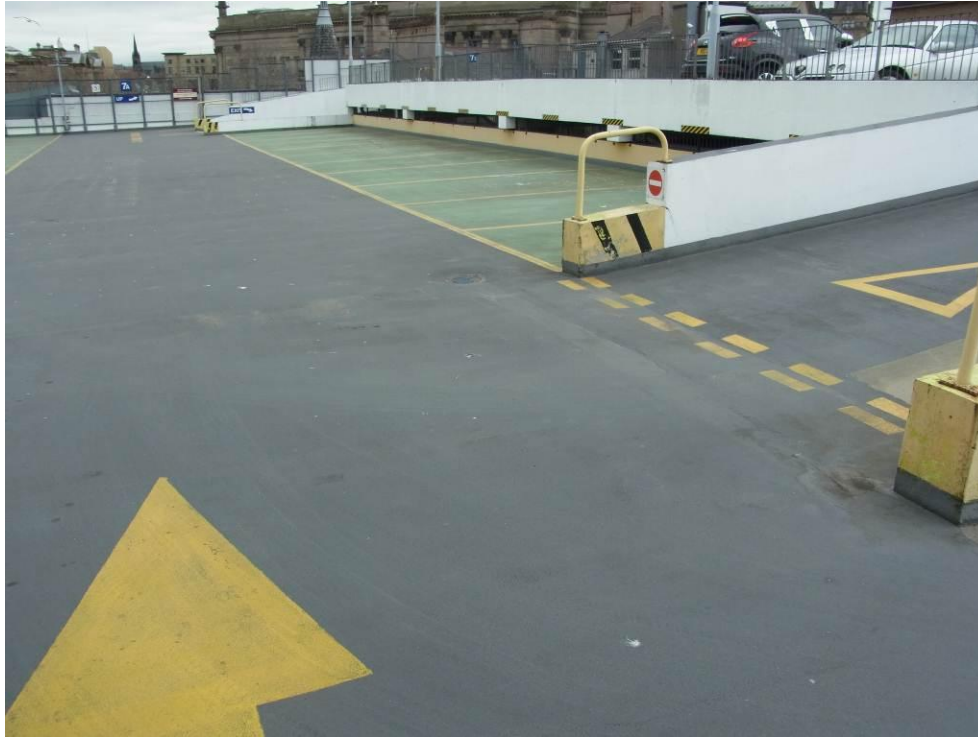
Figure 1 General view of Queen's Square car park

Comments	<p>The Deckmaster system had been applied to the top deck of the car park and is regularly trafficked.</p> <p>The surface appeared intact in all locations that were inspected.</p> <p>The surface sealer, which provides the colour to the system, was noted to have been worn away by vehicular traffic in some locations. However, the underlying waterproof membrane had not been affected.</p> <p>In some heavily trafficked locations, the aggregate was noted to have been ‘plucked’ from the upper layer of PU membrane. The lower layer of PU membrane appeared intact beneath.</p> <p>There was no evidence of water ingress to the deck below.</p> <p>BRE understood that the only maintenance works that had been carried out were the repainting of the marking lines and the addition of anti-slip pedestrian paths on the vehicle ramps.</p>
----------	---

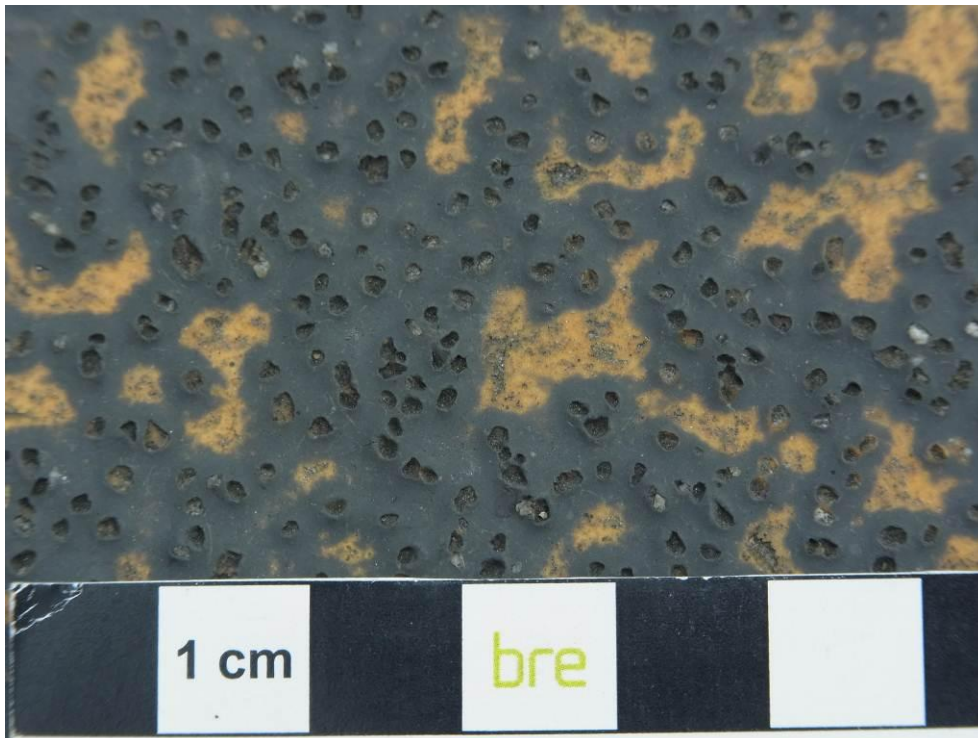
Figure 2 Queen's Square, abrasion of pigmented top coat and 'plucking' of some aggregate particles in the most heavily trafficked areas

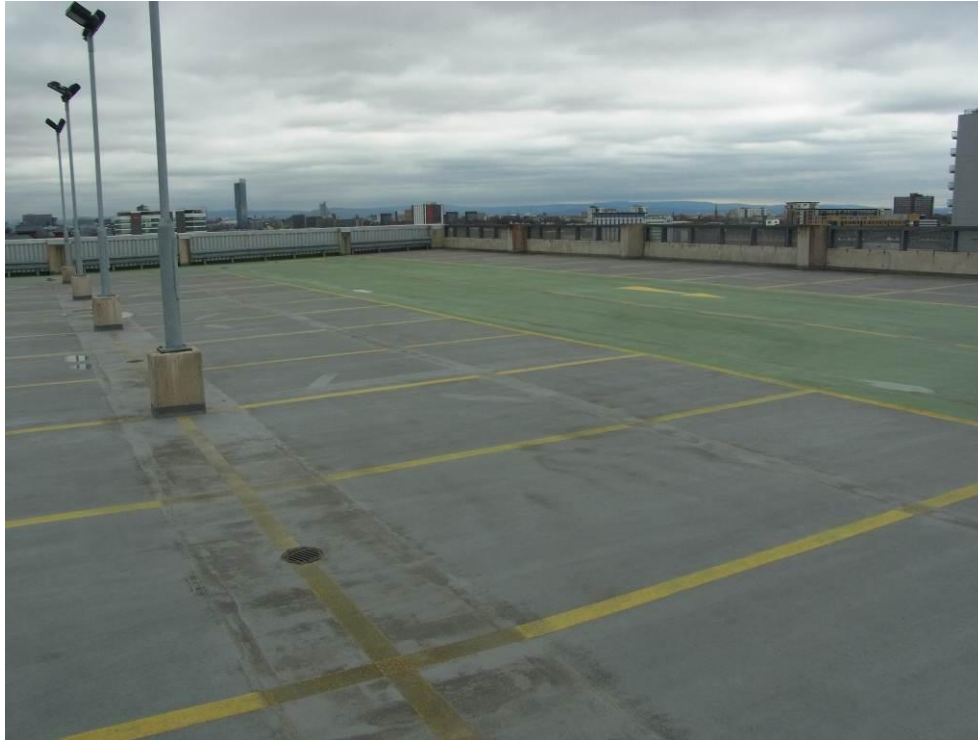
Figure 3 General view of Lowry Centre car park

Comments	<p>The Deckmaster system had been applied to approximately half of the top deck of the car park and was regularly trafficked.</p> <p>The surface appeared intact in all locations that were inspected.</p> <p>The surface sealer was noted to have been worn away by vehicular traffic in some locations and some aggregate had been ‘plucked’ from the surface. However, the underlying waterproof membrane had not been affected.</p> <p>There was no evidence of water ingress to the deck below.</p> <p>BRE understood that a ‘value engineering’ exercise by the designers had removed reinforced strips over slab movement joints from the specification; but that these had later been found to be necessary and consequently were applied by Deckmaster.</p>
----------	--

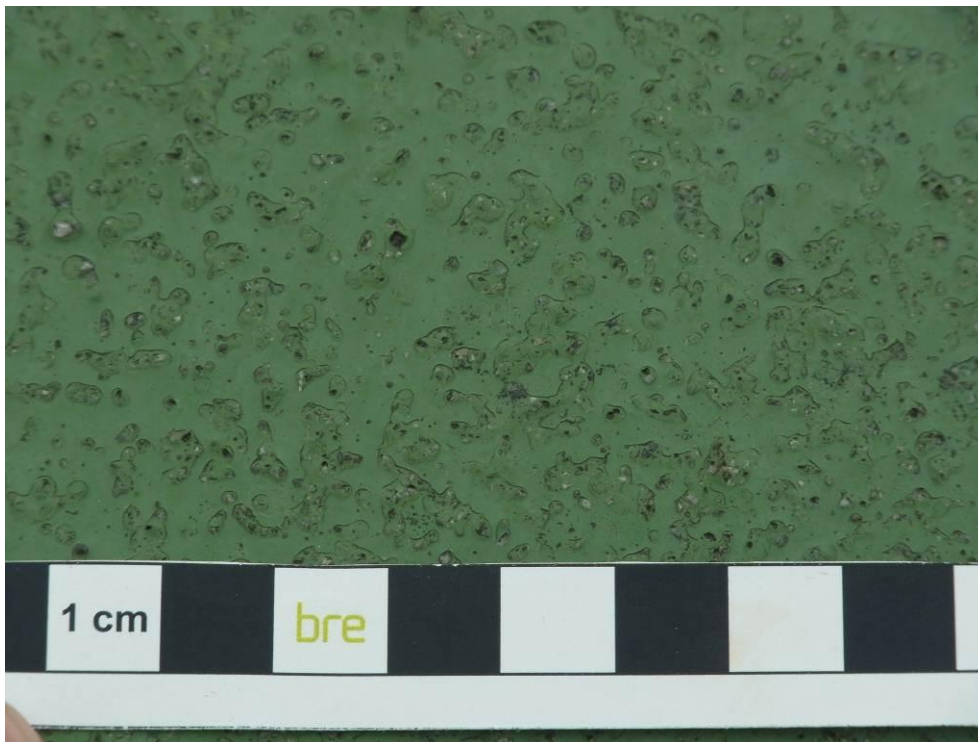
Figure 4 Lowry Centre, localised abrasion of pigmented top coat

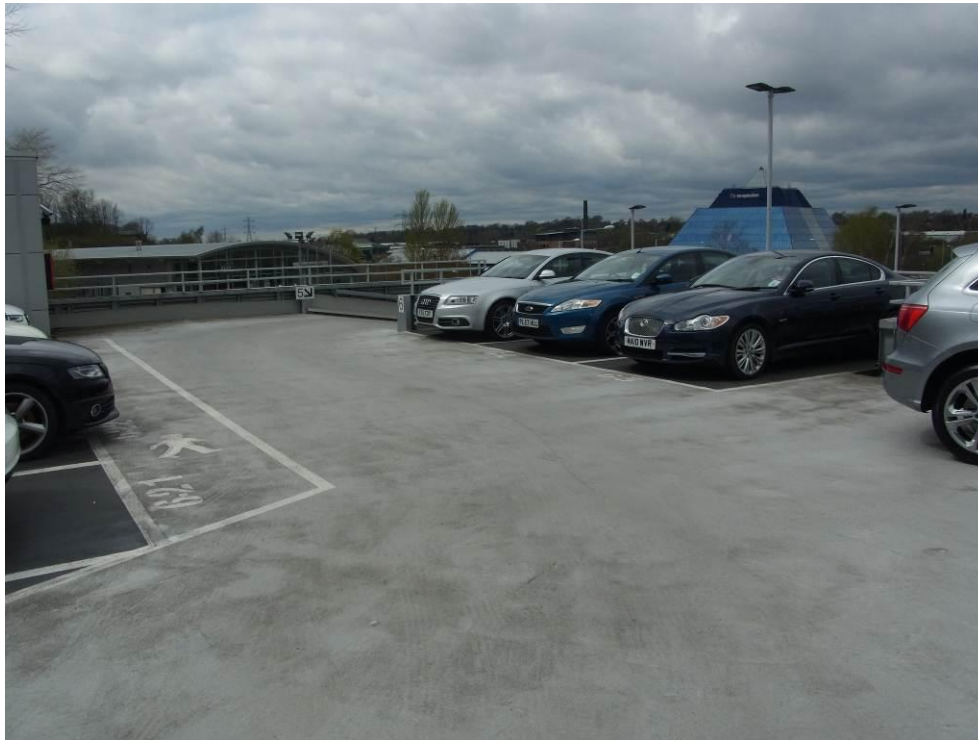
Figure 5 General view of Stockport Audi car park

Comments	<p>The Deckmaster system had been applied to the top deck of the car park and was regularly trafficked.</p> <p>The surface appeared intact in all locations that were inspected.</p> <p>The surface sealer, which provides the colour to the system, was noted to have been worn away on the top of the aggregate particles by vehicular traffic. Some aggregate had been 'plucked' from the surface, leaving a small hole in the upper layer of membrane while the underlying waterproof membrane had not been affected.</p> <p>There was no evidence of water ingress to the deck below.</p>
----------	--

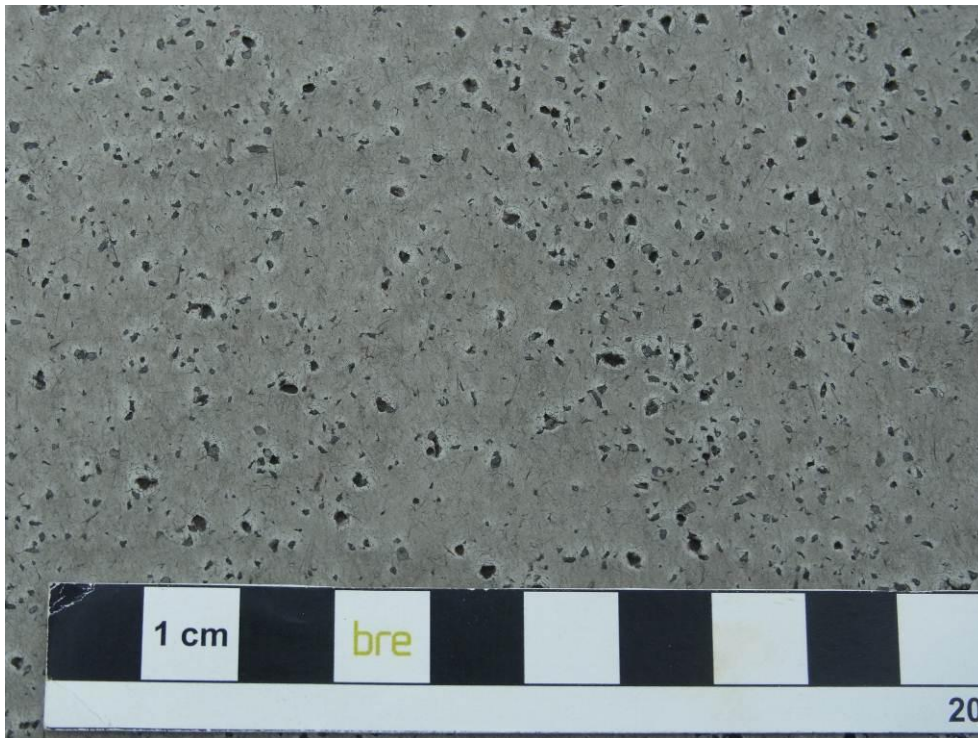
Figure 6 Stockport Audi, localised abrasion of pigmented top coat
